BUREAU OF SHIPS GROUP
TECHNICAL INSPECTION REPORT

OPERATION CROSSROADS.
U.S.S. CATRON (APA 71).
TEST BAKER [U]. (8)

U.S.S. CATRON (APA71)

TECHNICAL INSPECTION REPORT

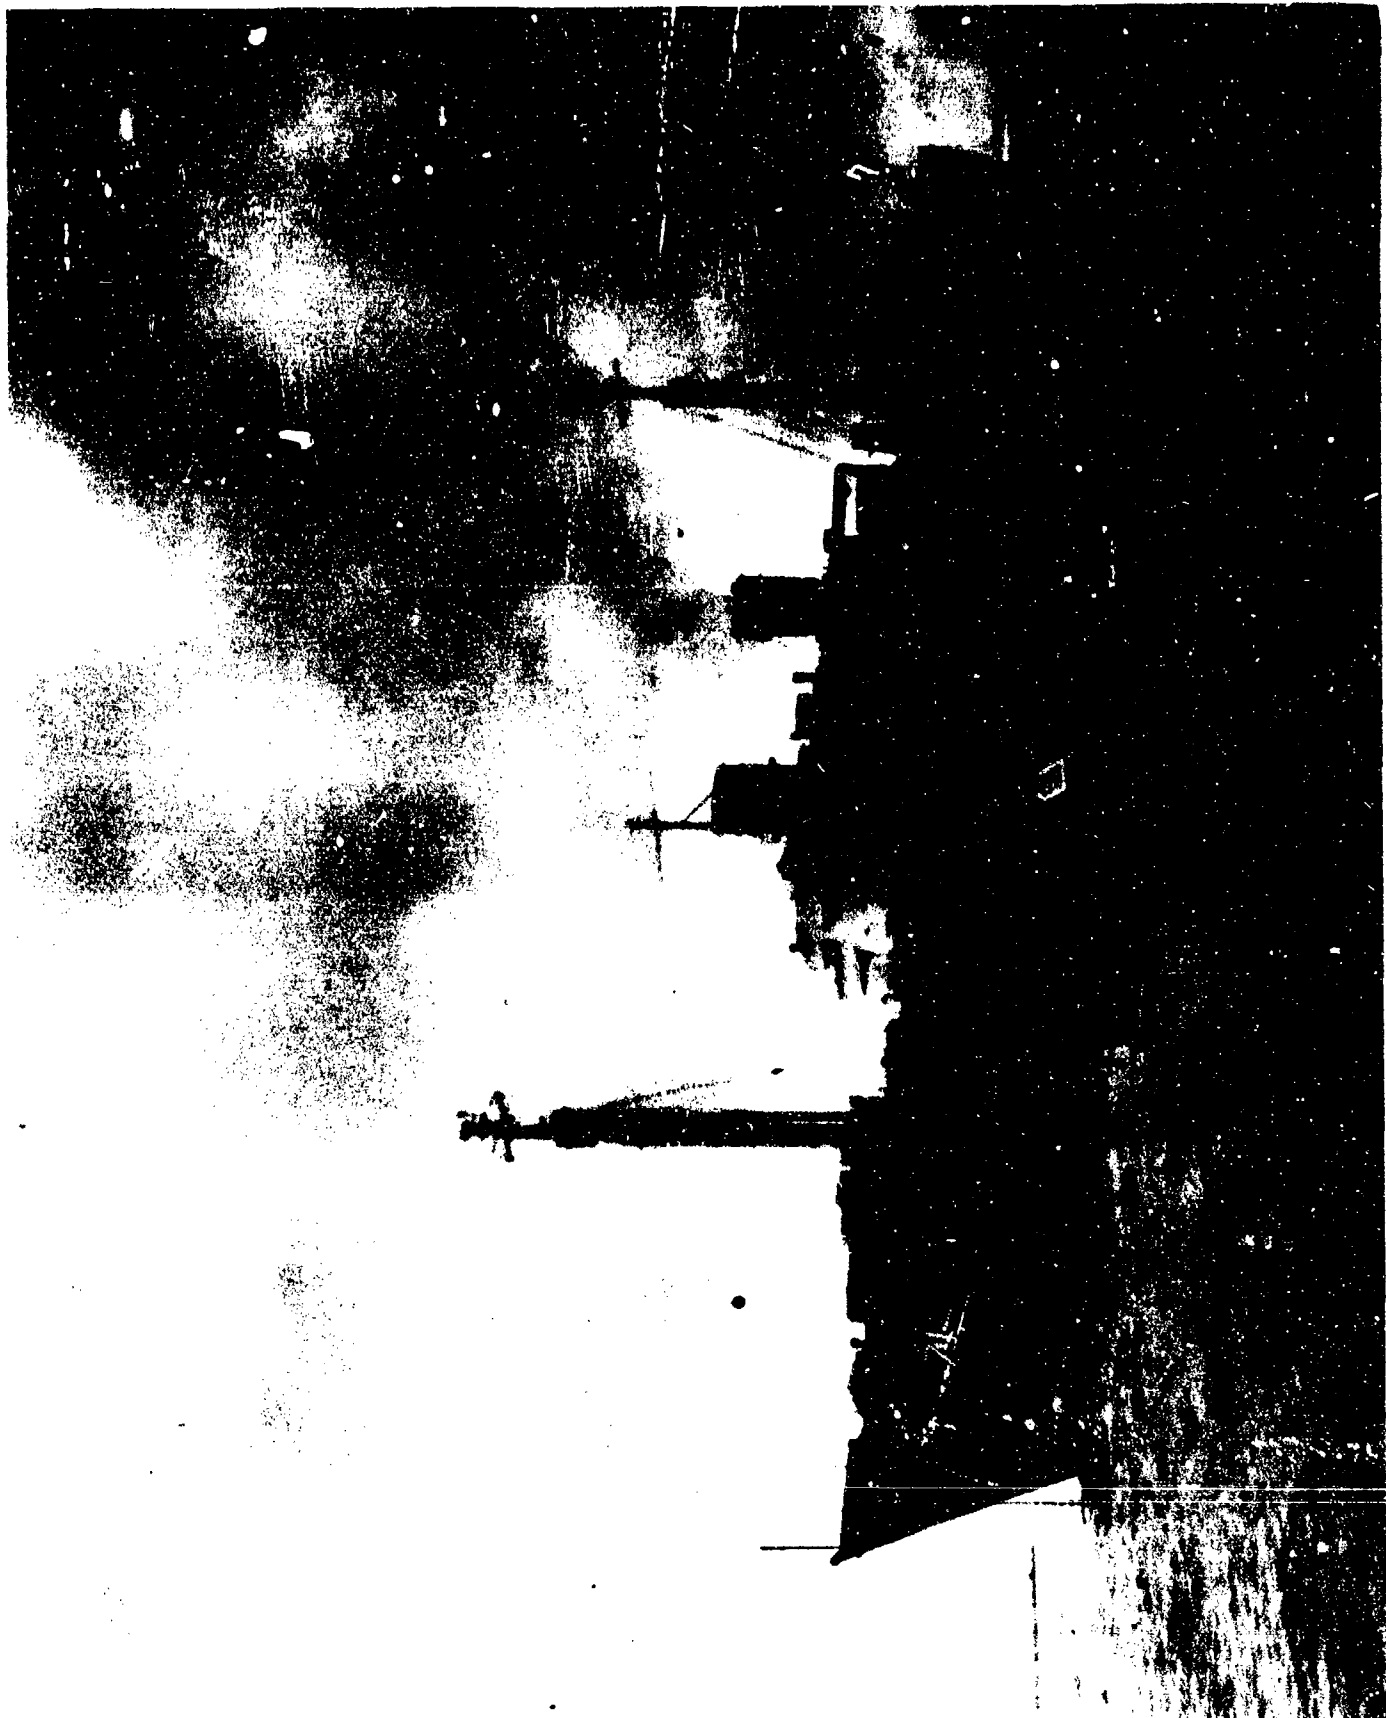
AA-CR-227-289-46. View from off port bow after Test B.

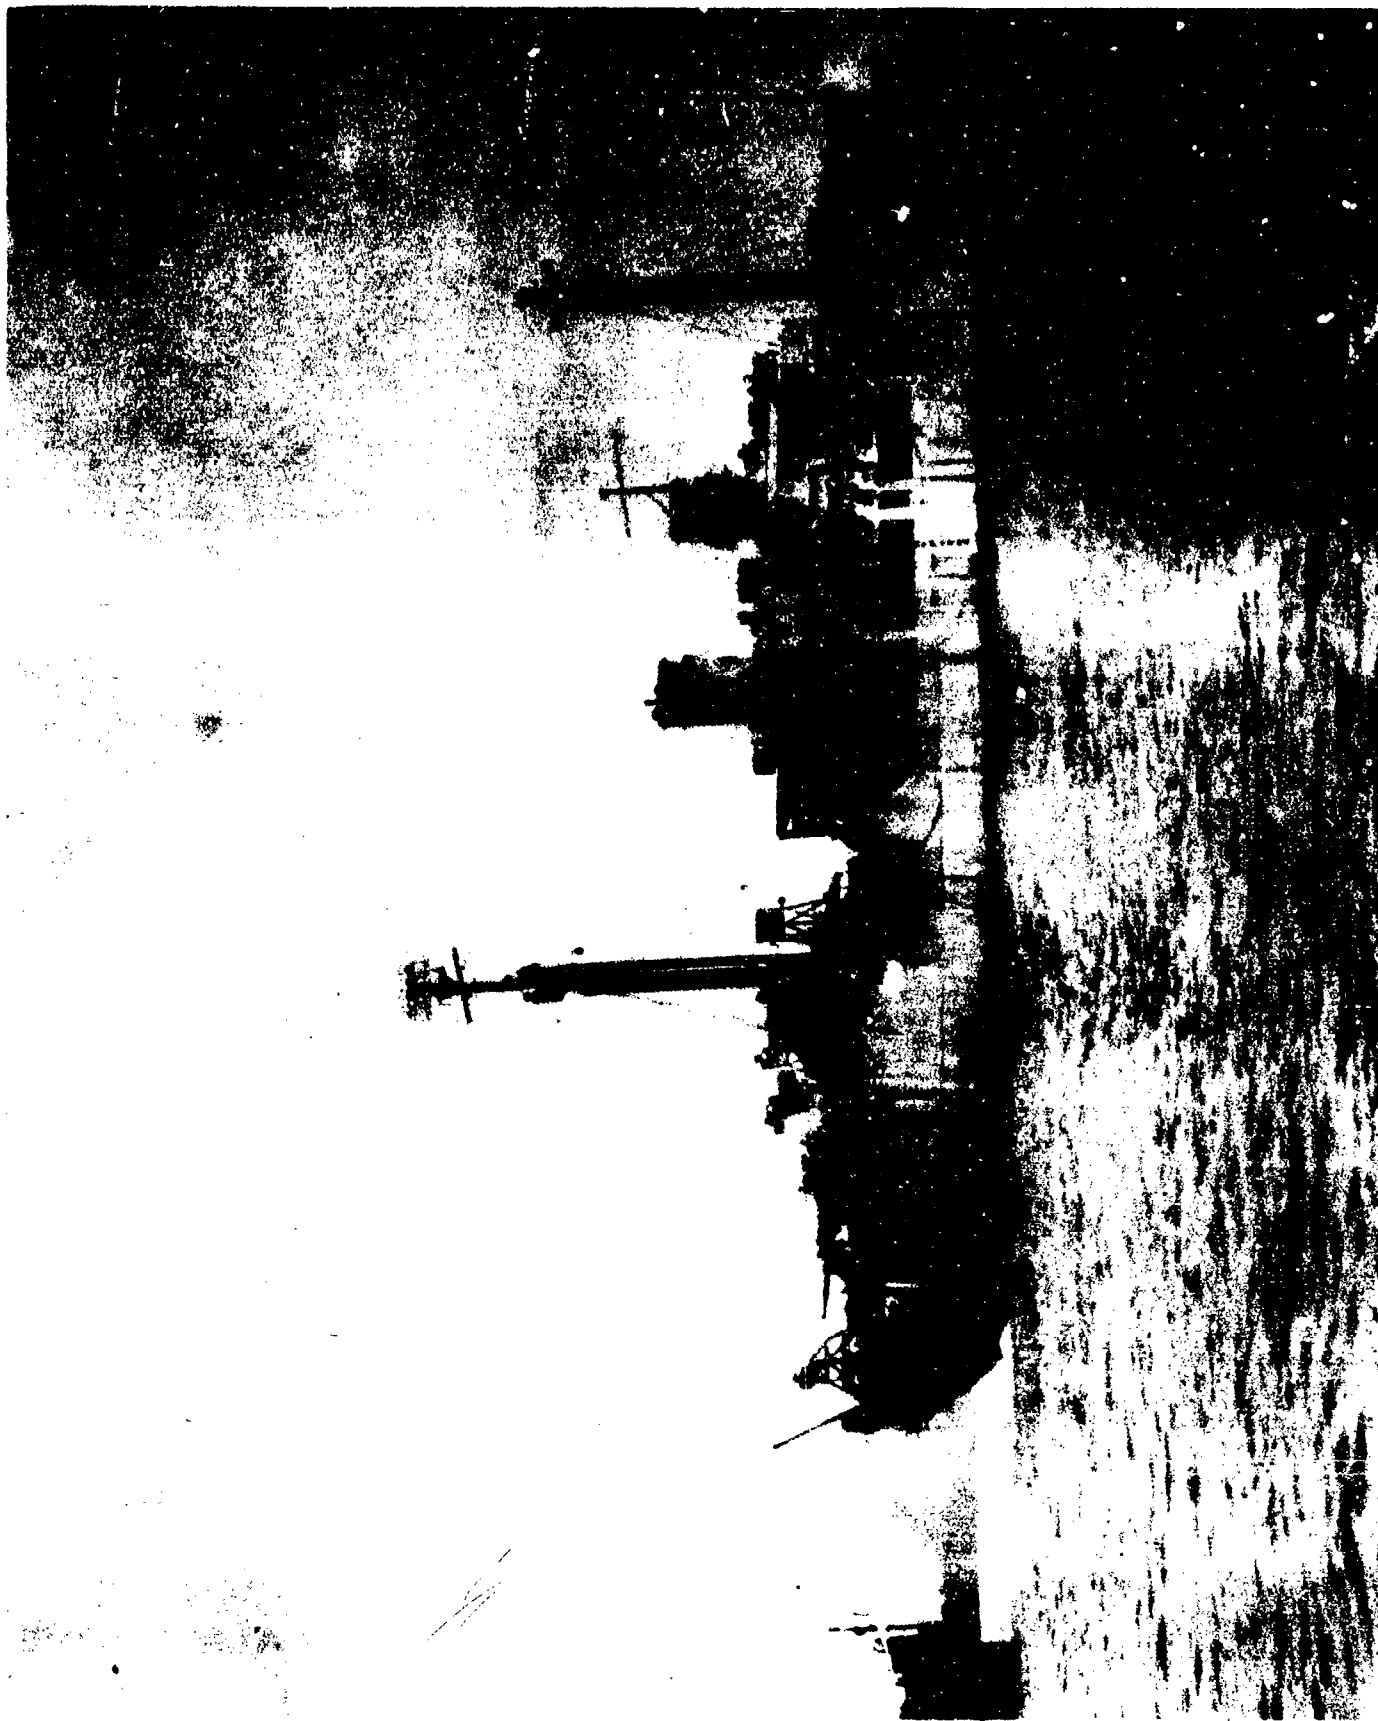
AB-CR-227-289-42. View from off starboard quarter after Test B.
